Subject: Trip Report for Marine Shale

1. I conducted a corrective action site inspection at the Marine Shale Facility near Amelia, LA, beginning Thursday, April 30, 2009. I was accompanied by Vicky Hadwin from Louisiana Department of Environmental Quality (LDEQ). The purpose of the inspection was to support the LDEQ in the project management of a Department of Justice (DOJ) Consent Decree.

Official Photograph Log

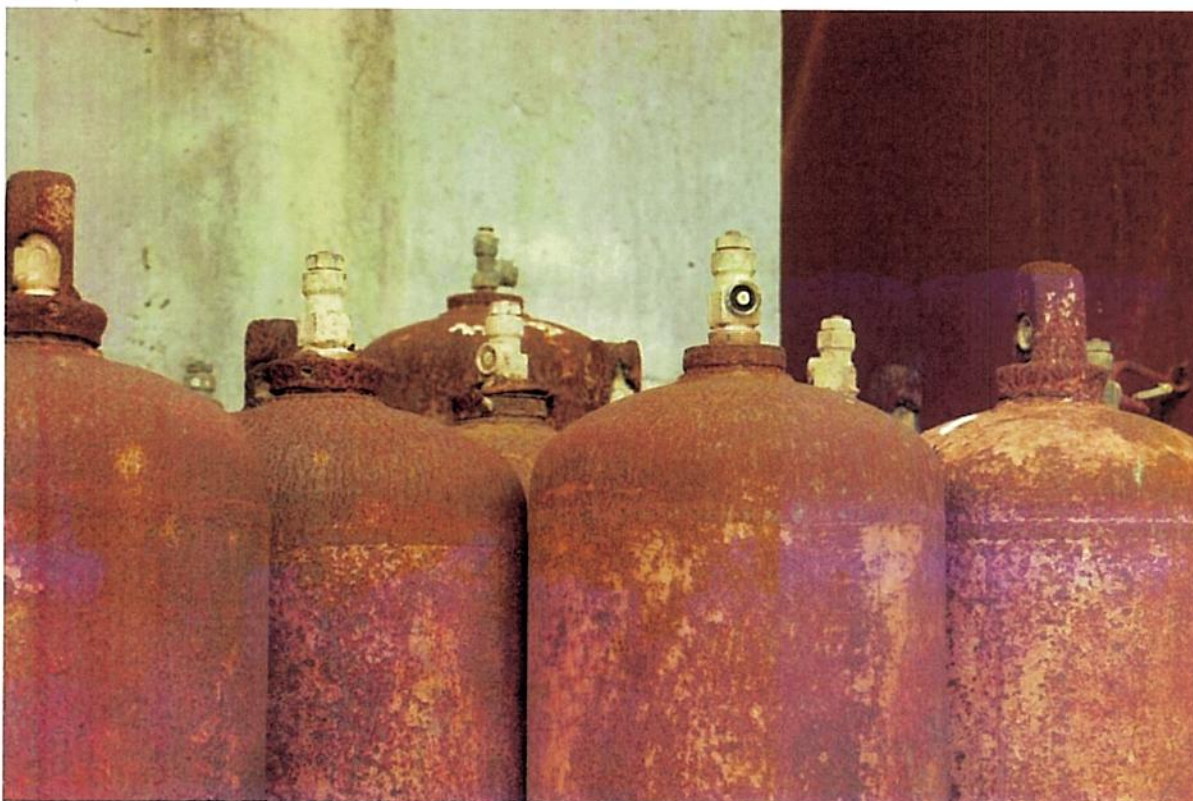
Photographer: C Barnes	Date: 4-30-09	Time: 0900 to 1300
City/County: Amelia,		State: LA
Location: Marine Shale Facility		
Subject: Multiple portions of the facility. Pressurized container storage rack – materials in very poor condition. Contents undetermined.

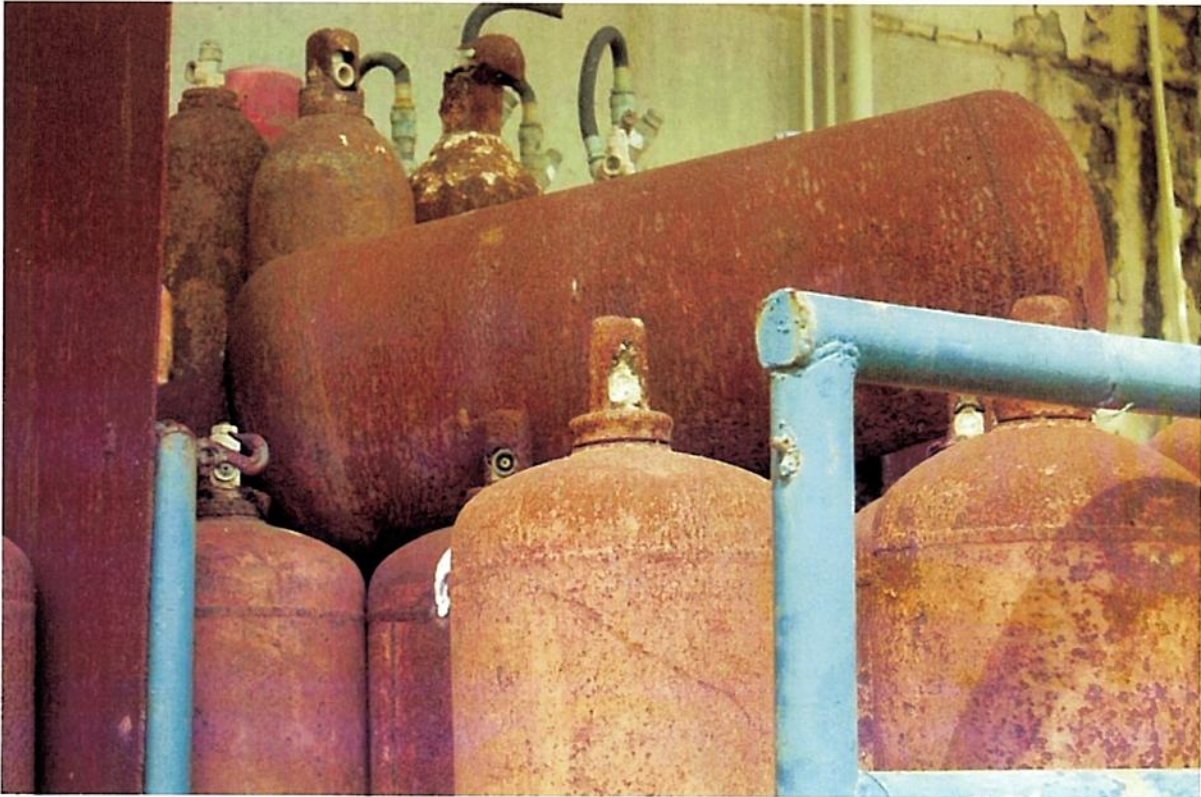
Photographer: C Barnes	Date: 4-30-09	Time: 0900 to 1300
City/County: Amelia,		State: LA
Location: Marine Shale Facility		
Subject: Multiple portions of the facility. Pressurized container storage rack – materials in very poor condition. Contents undetermined.

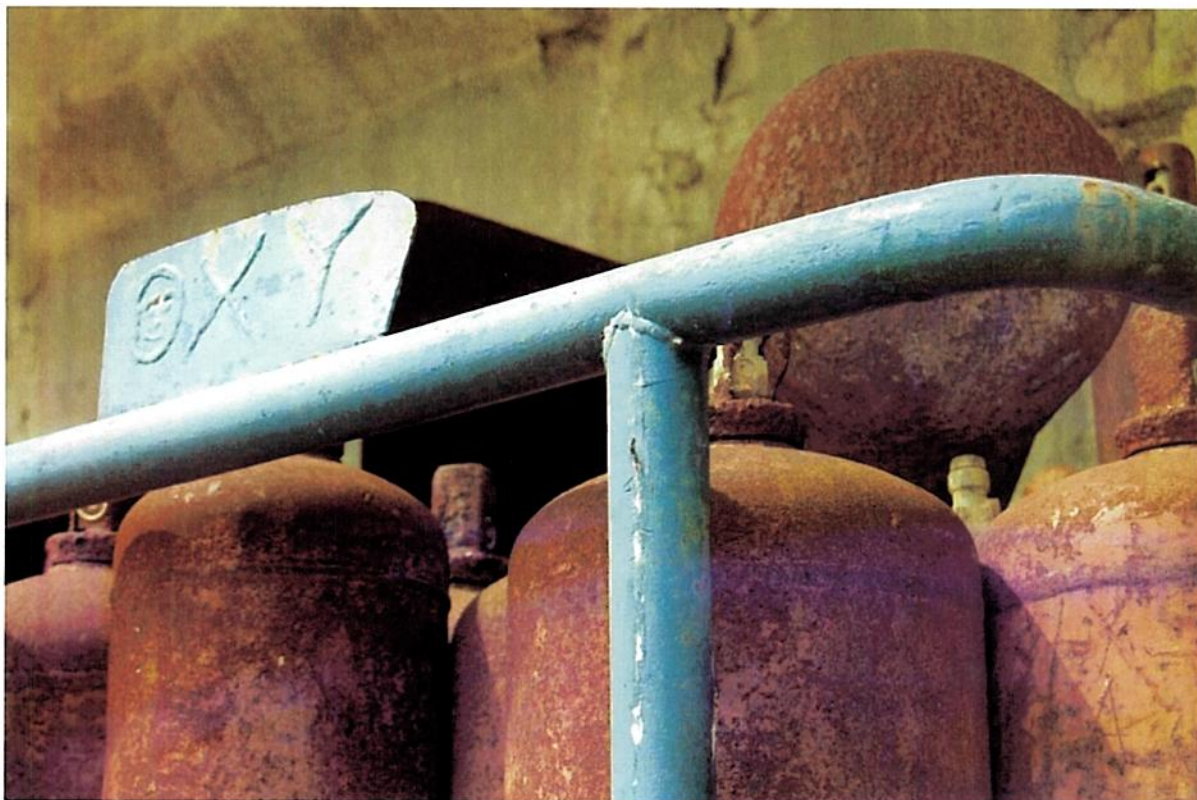
Photographer: C Barnes	Date: 4-30-09	Time: 0900 to 1300
City/County: Amelia,		State: LA
Location: Marine Shale Facility		
Subject: Multiple portions of the facility. Pressurized container storage rack – materials in very poor condition. Contents undetermined.

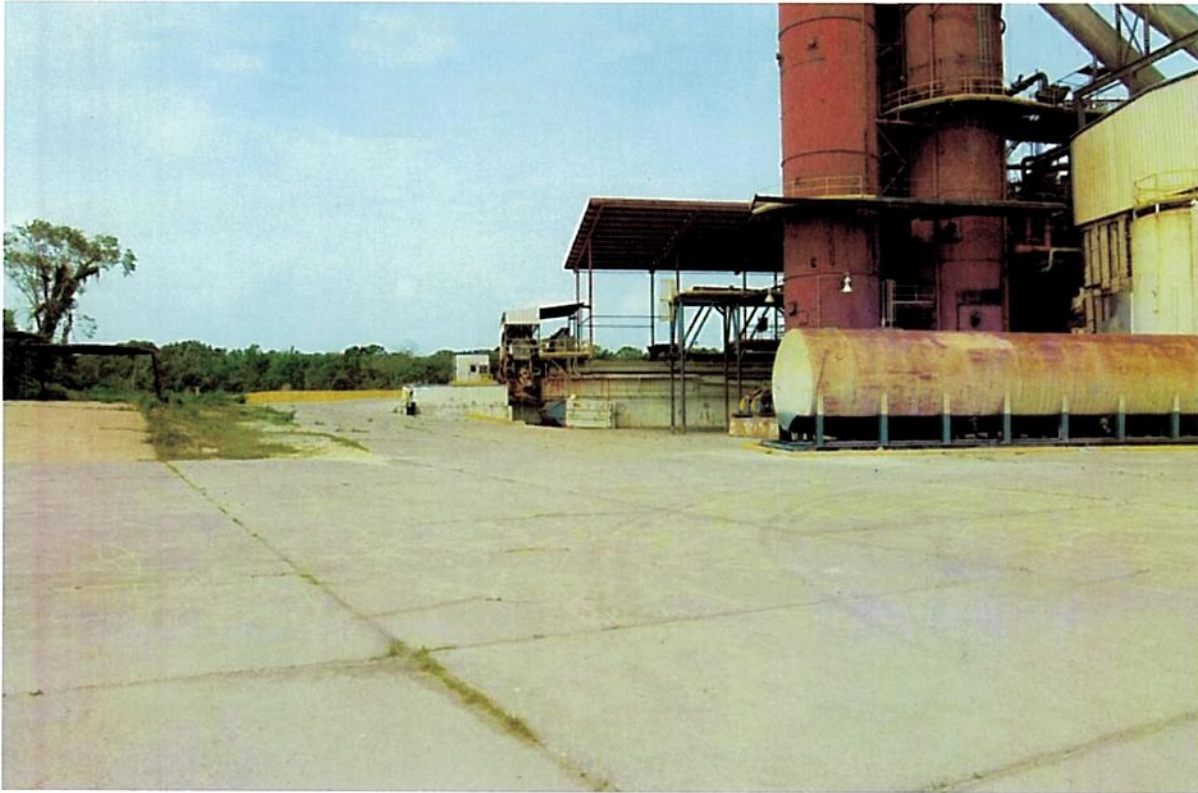
Photographer: C Barnes	Date: 4-30-09	Time: 0900 to 1300
City/County: Amelia,		State: LA
Location: Marine Shale Facility		
Subject: Multiple portions of the facility. Truck unloading terminal. Truck trailer is still inside the facility

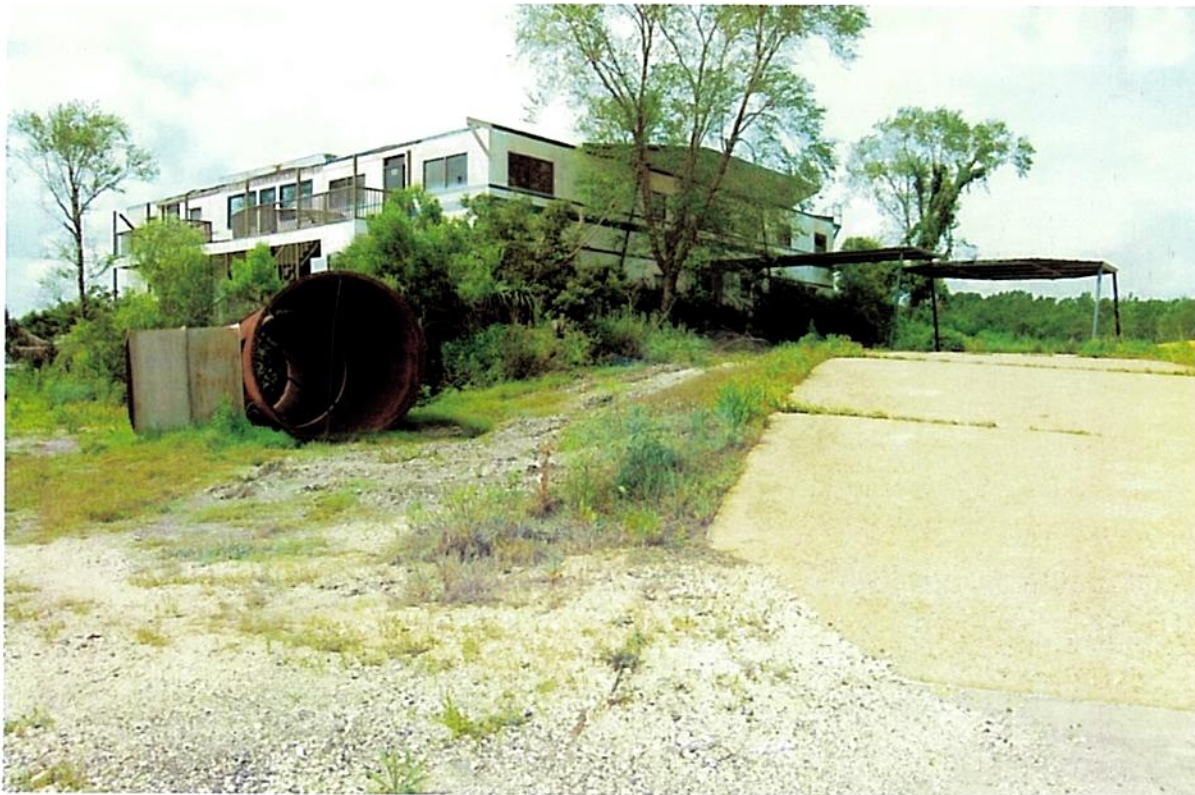
Photographer: C Barnes	Date: 4-30-09	Time: 0900 to 1300
City/County: Amelia,		State: LA
Location: Marine Shale Facility		
Subject: Multiple portions of the facility. Headquarters building

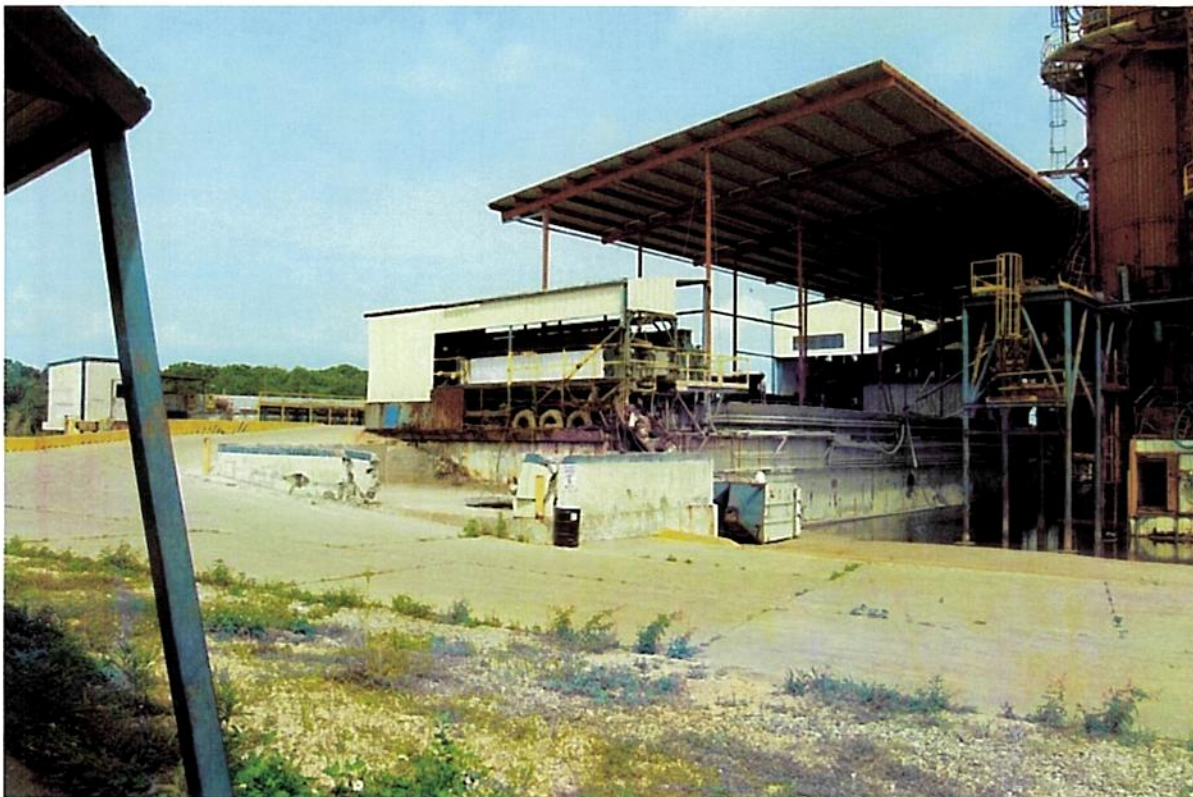
Photographer: C Barnes	Date: 4-30-09	Time: 0900 to 1300
City/County: Amelia,		State: LA
Location: Marine Shale Facility		
Subject: Multiple portions of the facility. Truck unloading terminal. Truck trailer is still inside the facility

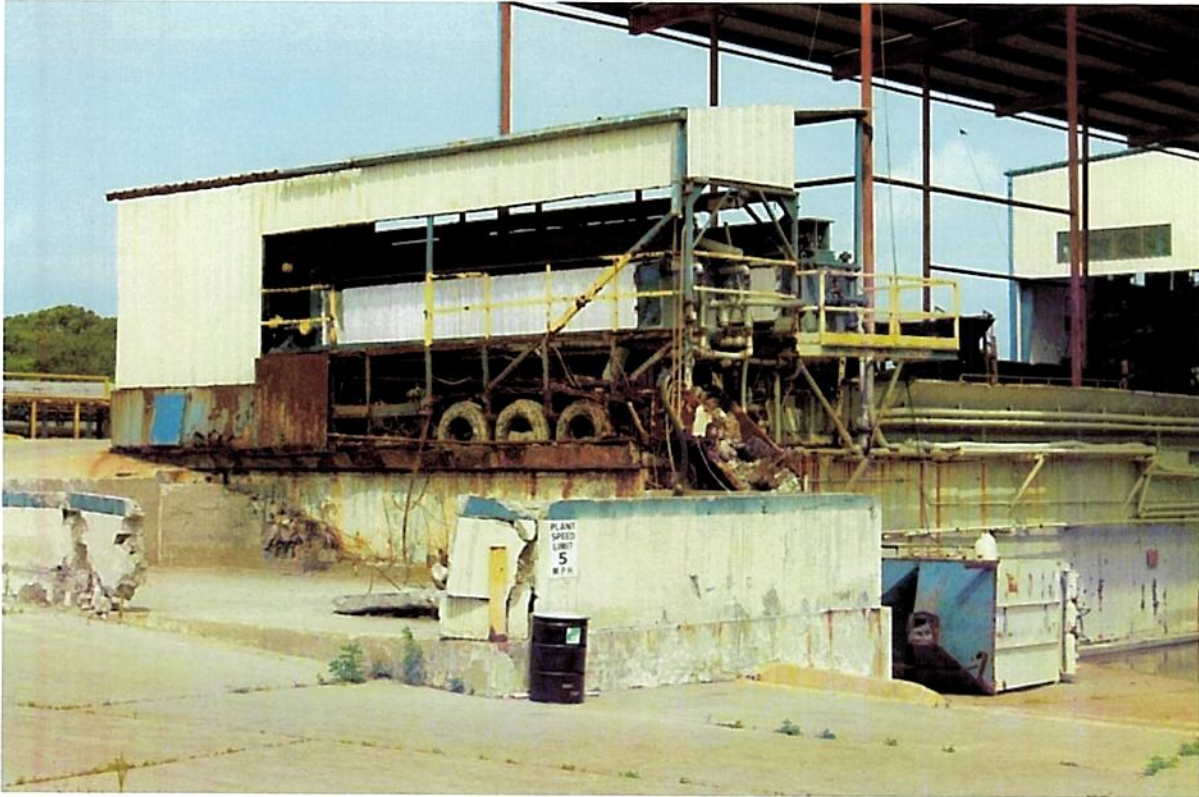
Photographer: C Barnes	Date: 4-30-09	Time: 0900 to 1300
City/County: Amelia,		State: LA
Location: Marine Shale Facility		
Subject: Multiple portions of the facility. Truck unloading terminal. Truck trailer is still inside the facility

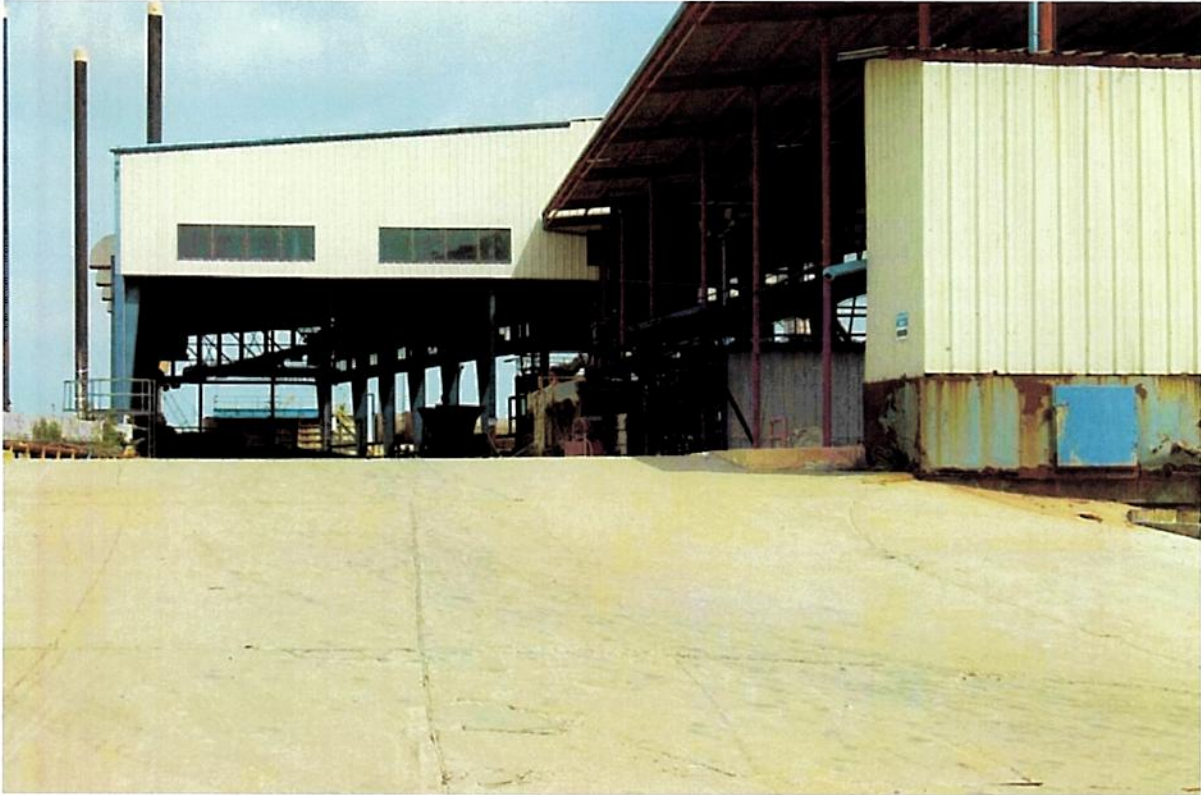
Photographer: C Barnes	Date: 4-30-09	Time: 0900 to 1300
City/County: Amelia,		State: LA
Location: Marine Shale Facility		
Subject: Multiple portions of the facility. Bulk unloading area

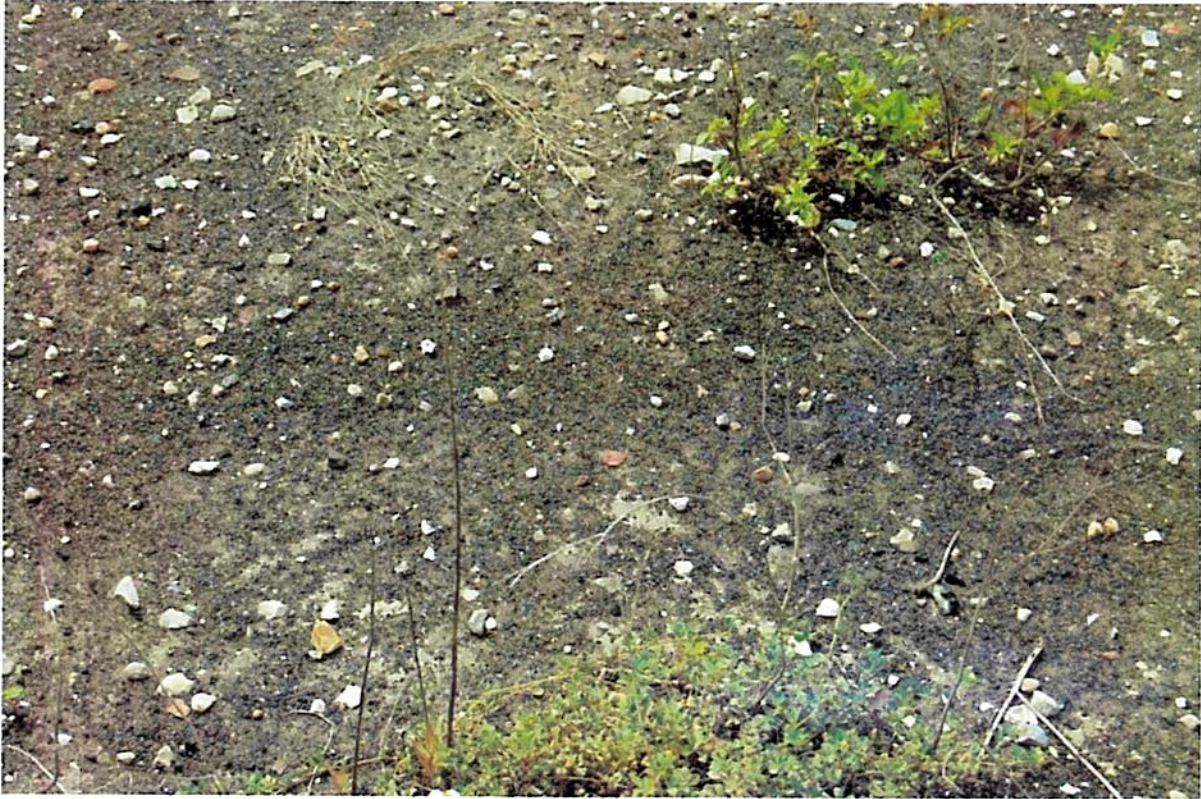
Photographer: C Barnes	Date: 4-30-09	Time: 0900 to 1300
City/County: Amelia,		State: LA
Location: Marine Shale Facility		
Subject: Multiple portions of the facility. Ash & clinker from the incinerator.

7. Areas that need additional emphasis and investigation include:
 - a. Ash remaining on site - metals
 - b. Hydraulic fluid remaining on site – metals, organics, etc.

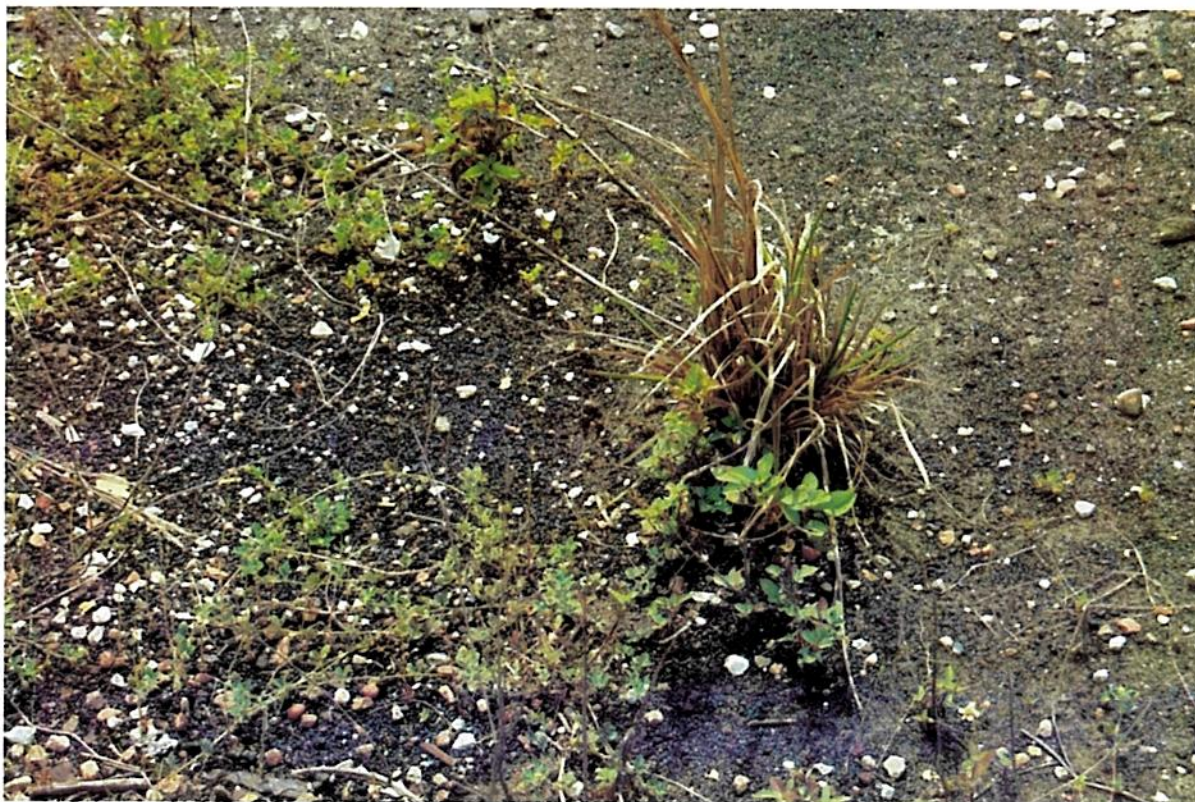
Photographer: C Barnes	Date: 4-30-09	Time: 0900 to 1300
City/County: Amelia,		State: LA
Location: Marine Shale Facility		
Subject: Multiple portions of the facility. Ash & clinker from the incinerator

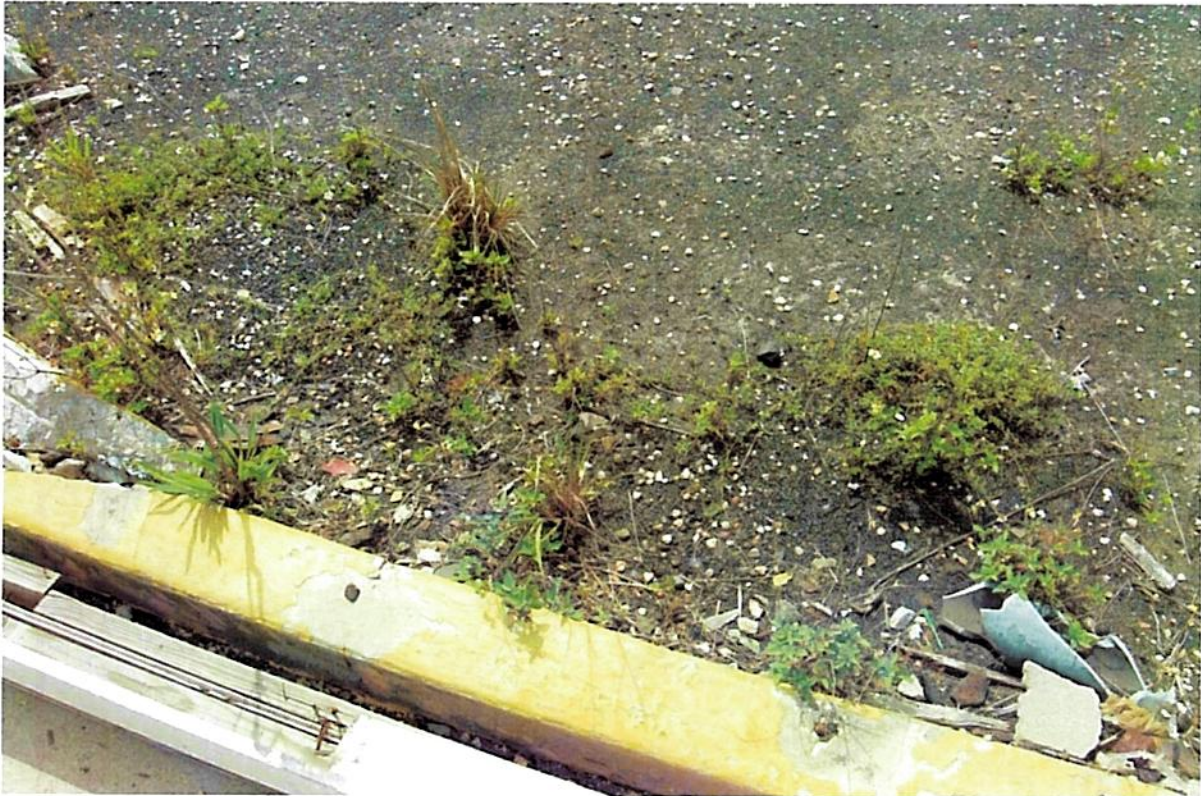
Photographer: C Barnes	Date: 4-30-09	Time: 0900 to 1300
City/County: Amelia,		State: LA
Location: Marine Shale Facility		
Subject: Multiple portions of the facility. Ash & Slag/clinker from the incinerator

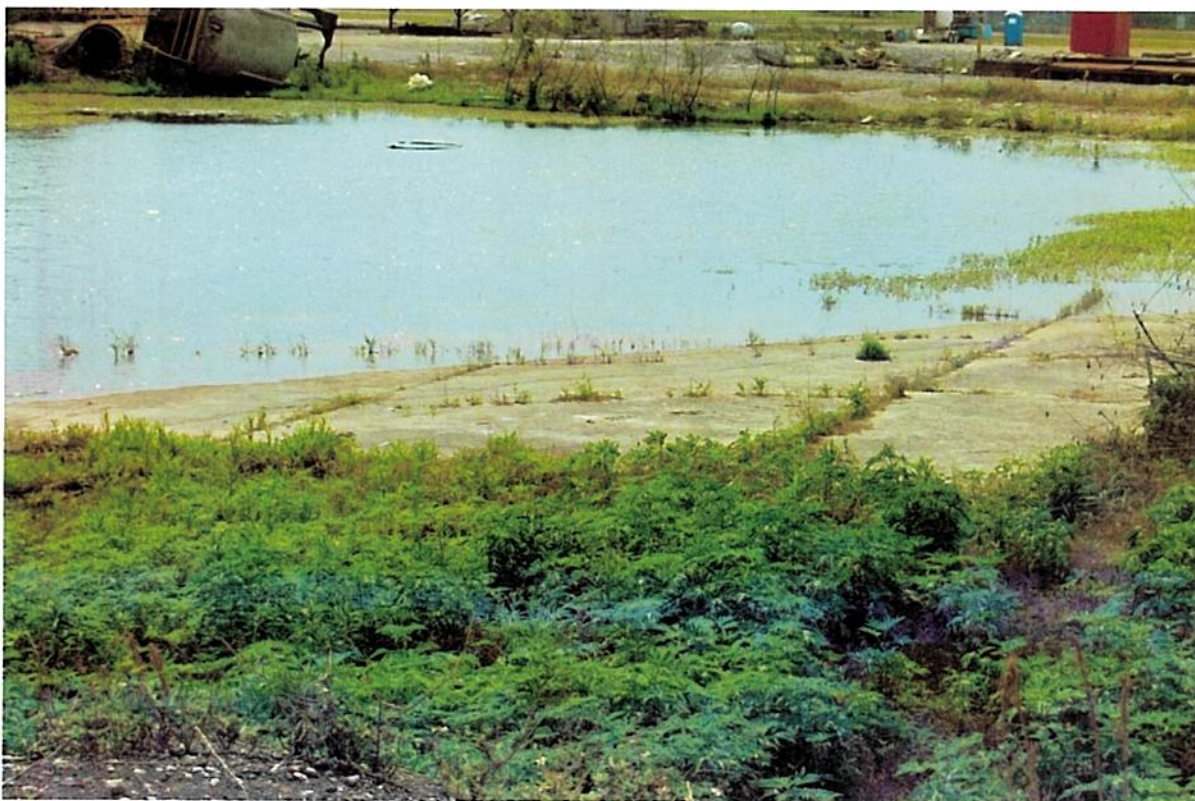
Photographer: C Barnes	Date: 4-30-09	Time: 0900 to 1300
City/County: Amelia,		State: LA
Location: Marine Shale Facility		
Subject: Multiple portions of the facility. Creosote storage area - underwater

- c. Barge slip – metals, PCBs, organics
 - d. Refractory bricks – metals, radiation
 - e. Creosote pad – organics, metals, volatiles, semi-volatiles, etc.

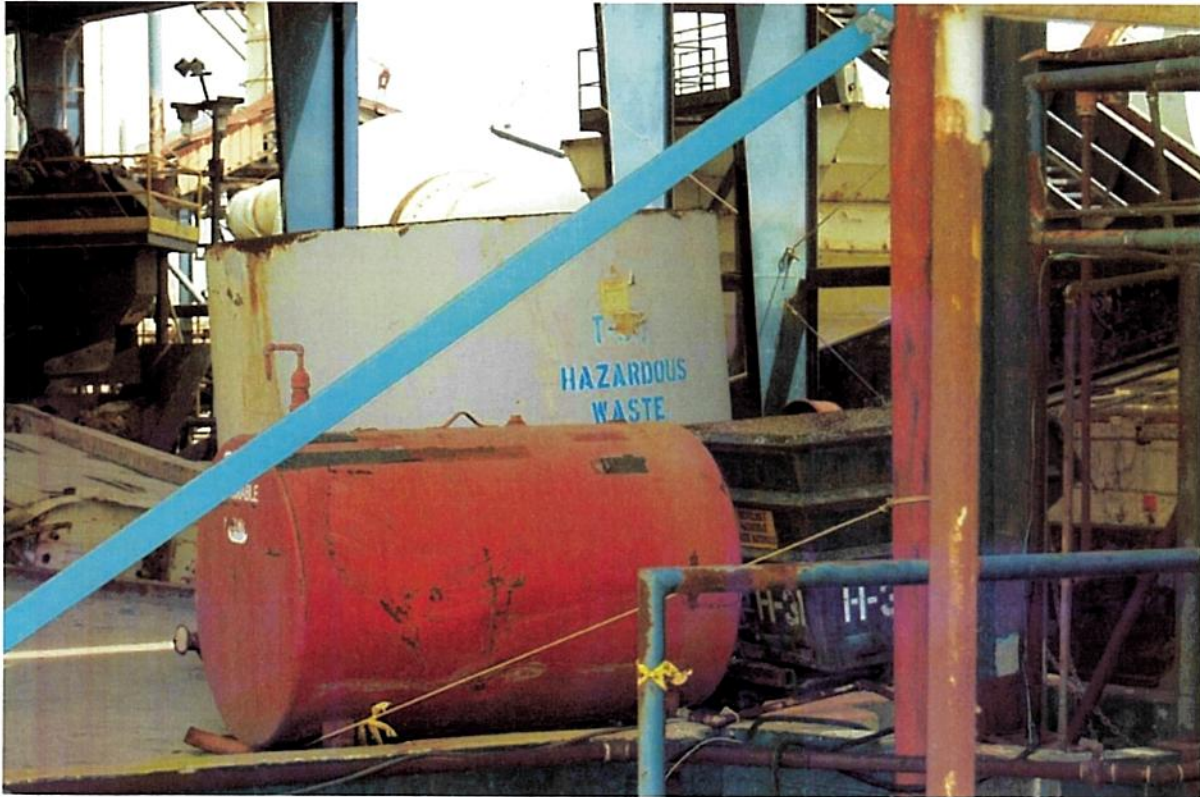
Photographer: C Barnes	Date: 4-30-09	Time: 0900 to 1300
City/County: Amelia,		State: LA
Location: Marine Shale Facility		
Subject: Multiple portions of the facility. Hazardous Waste container in bulk unloading area.

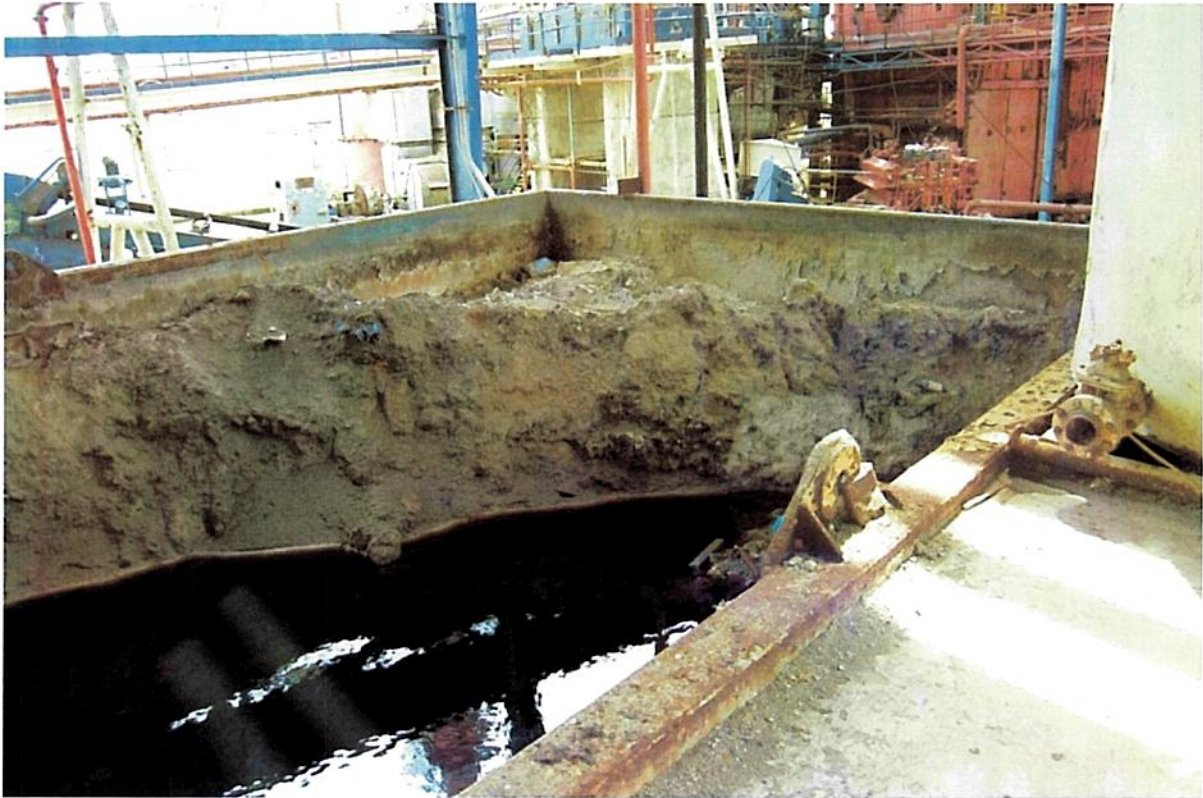
Photographer: C Barnes	Date: 4-30-09	Time: 0900 to 1300
City/County: Amelia,		State: LA
Location: Marine Shale Facility		
Subject: Multiple portions of the facility. Sludge & liquids in bulk unloading area

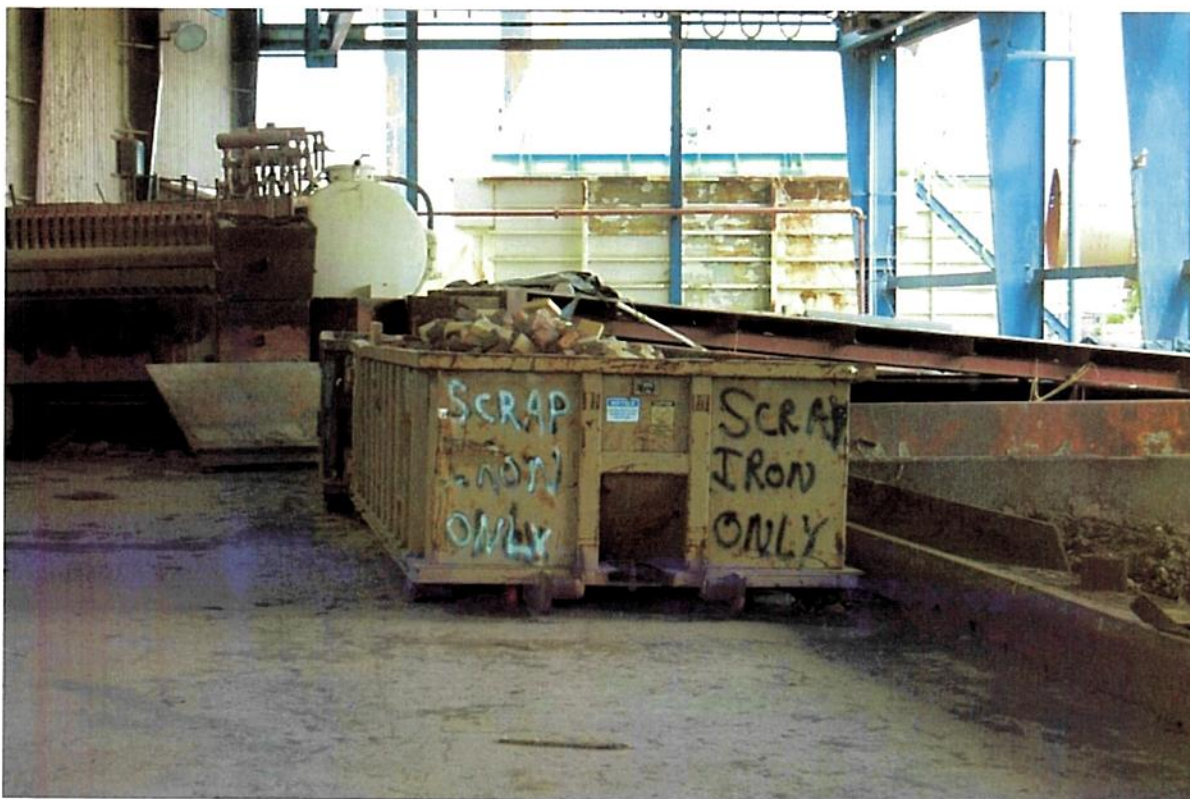
Photographer: C Barnes	Date: 4-30-09	Time: 0900 to 1300
City/County: Amelia,		State: LA
Location: Marine Shale Facility		
Subject: Multiple portions of the facility. Dumpster filled with fire brick – possible radiation issues

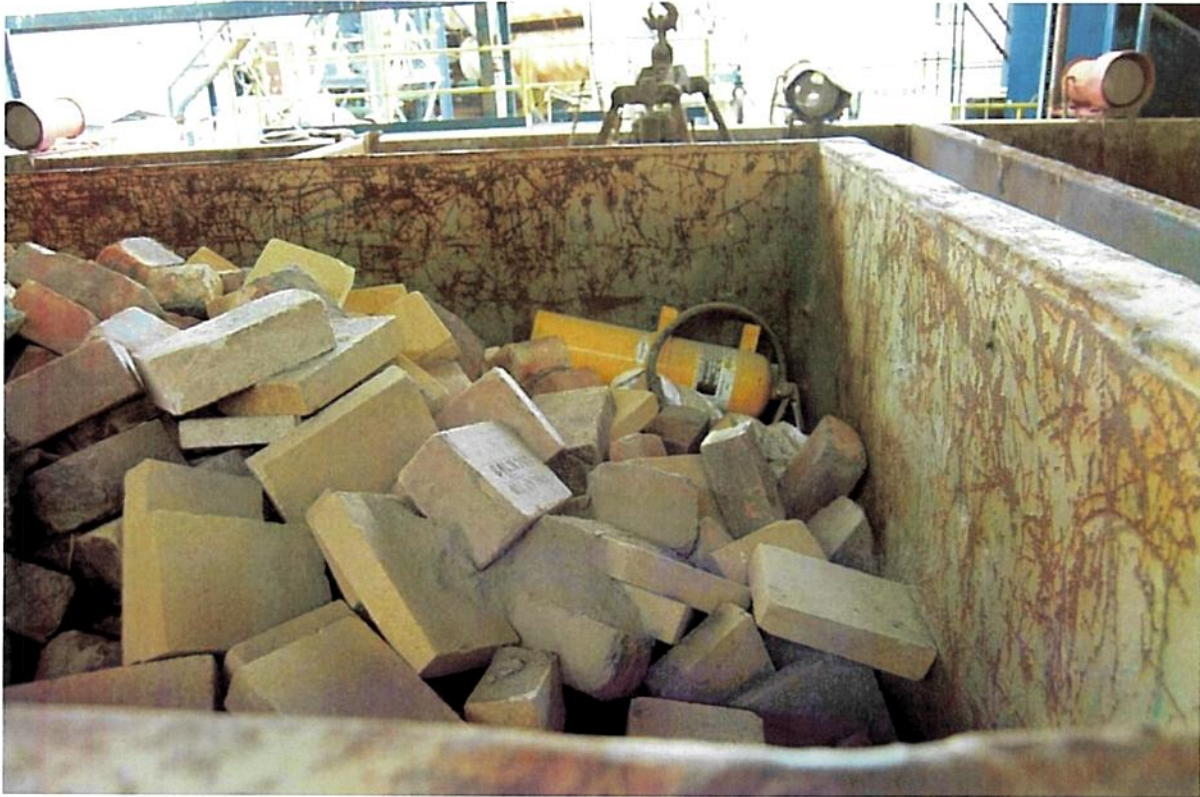
Photographer: C Barnes	Date: 4-30-09	Time: 0900 to 1300
City/County: Amelia,		State: LA
Location: Marine Shale Facility		
Subject: Multiple portions of the facility. Fire Brick potential radiation issues

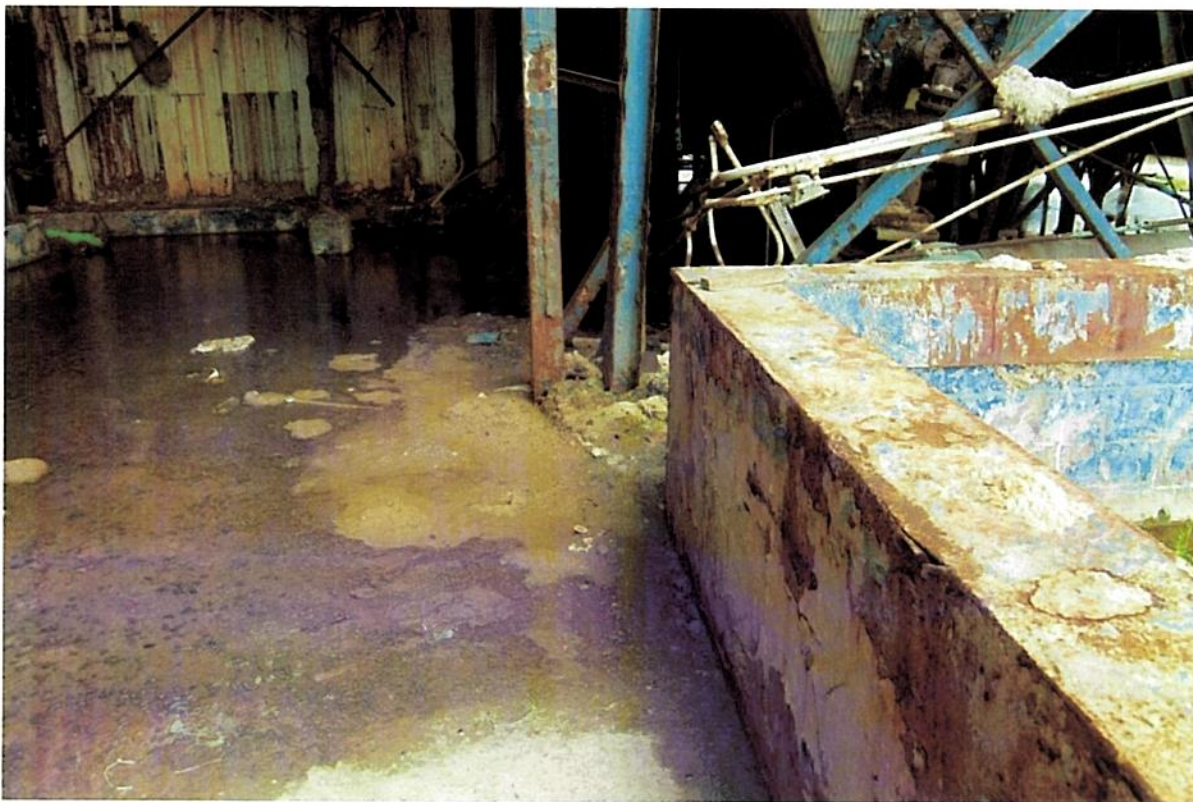
Photographer: C Barnes	Date: 4-30-09	Time: 0900 to 1300
City/County: Amelia,		State: LA
Location: Marine Shale Facility		
Subject: Multiple portions of the facility. Standing water under dust collectors
